**International Road Tunnel Fire Detection  
Research Project – Phase II**

**Task 7: Full-Scale Ventilated Fire Tests in a Laboratory  
Tunnel for Study of Tunnel Fire Detection Technologies**

**Z. G. Liu, G. Crampton, A. Kashef, G. Lougheed, E. Gibbs  
and S. Muradori**  
National Research Council of Canada

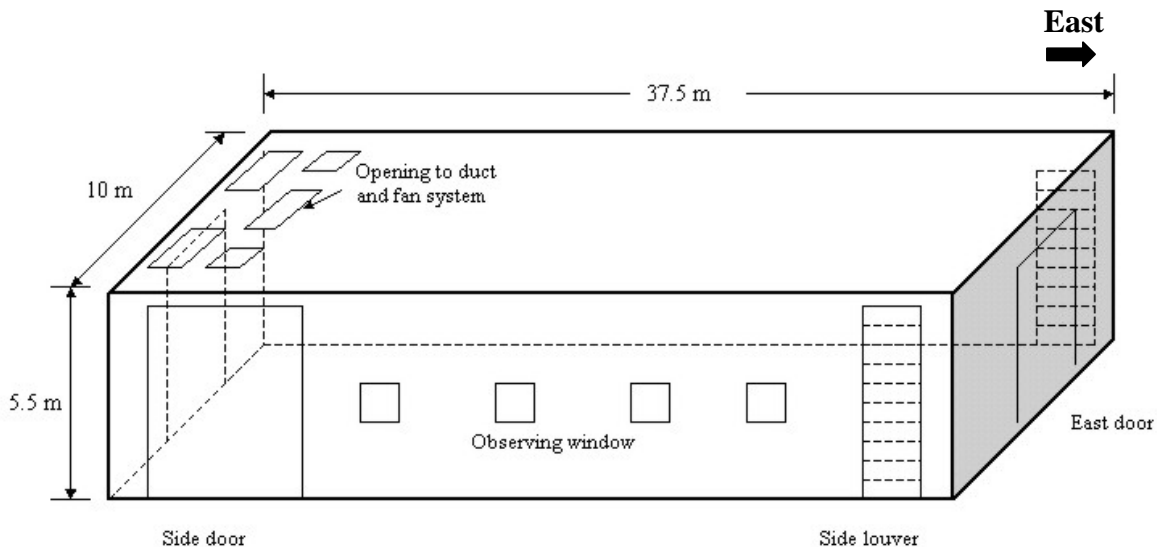
Figure 2.1. Schematic of the test tunnel

The full-scale fire tests were carried out in a new Carleton University laboratory research tunnel that is located at the site of the National Research Council (NRC) full-scale fire test facilities. The tunnel facility was 37.5 m long, 10 m wide and 5.5 m high. It has two end doors, one large side door that connected the tunnel to an adjacent burn hall at the West end of the tunnel, two side louvers at the East end of the tunnel, and a number of observation windows. It also has five ceiling openings located near the West end of the tunnel. They allow the air and smoke to vent through ducts and the fan system. A 3D view of the tunnel is shown in Figure 2.1. A detailed description of the tunnel was provided in the report for Task 2 of the project [8].

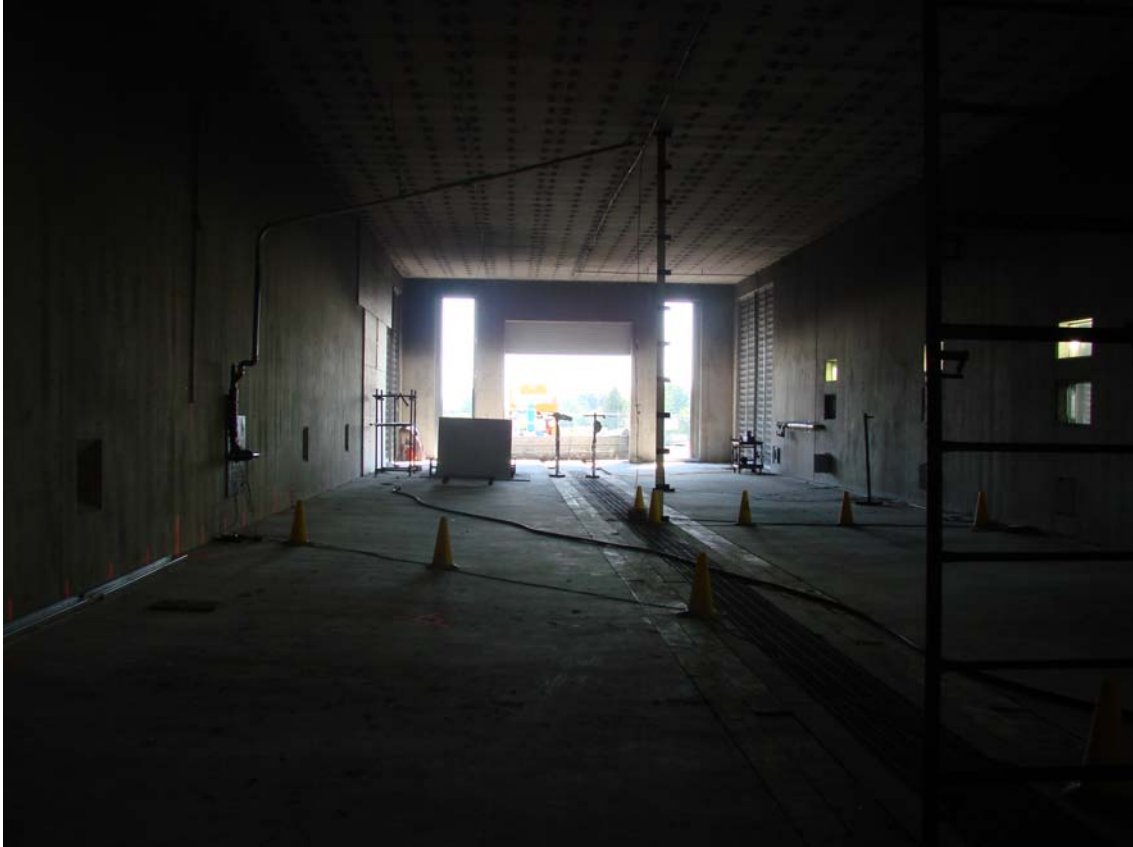
Figure 2.2. View of the East end of the tunnel facility

The mechanical fan system for the tunnel was operated during the tests. The air entered the tunnel through the open door at the East end of the tunnel and vented out the tunnel through the five ceiling openings near the West end of the tunnel. This provided a longitudinal airflow in the tunnel during the tests. Various air velocities were provided using the variable speed fan system. The maximum airflow speed near the fire source was approximately 3 m/s in the tests with full operation of the tunnel fan system. The distribution of air velocity in the tunnel was measured. The measurements and results are presented in Section 6 of this report.

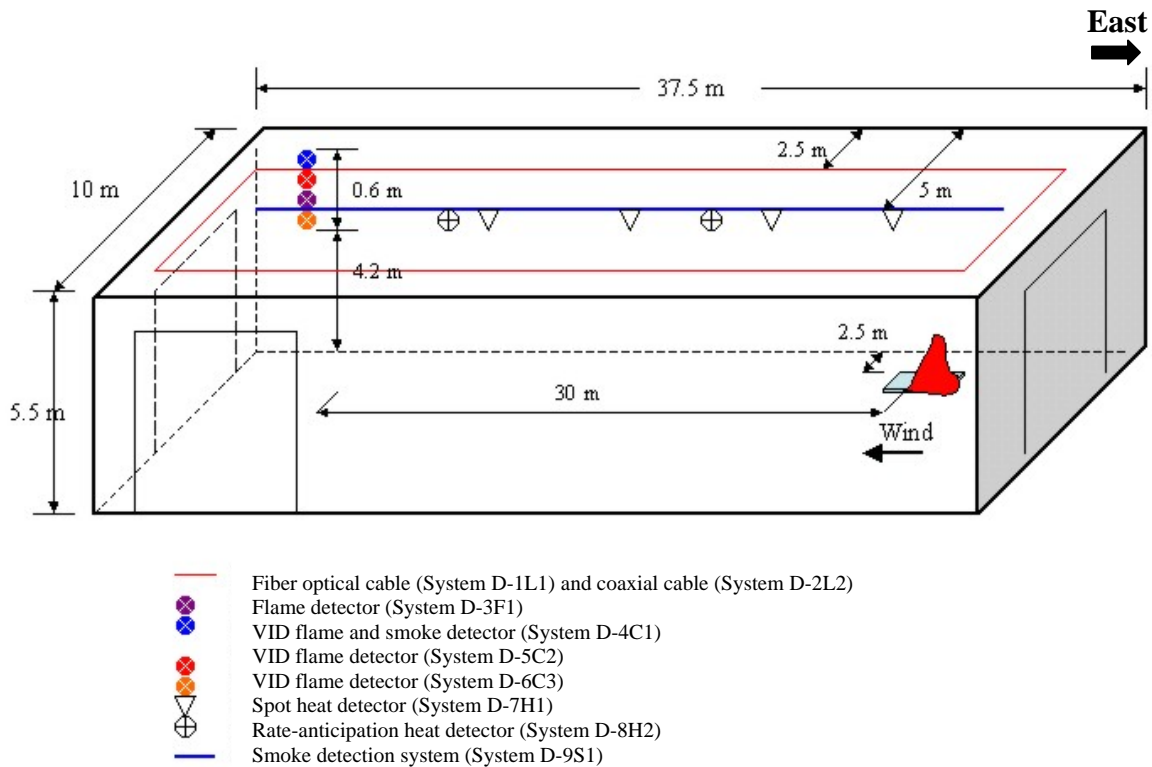
Figure 3.1. Schematic of detector/detection system setup in the test tunnel

The sensing cables of the two linear heat detection systems were installed on the ceiling of the tunnel to form a loop. The optical flame detector and three VID systems were installed on the North wall of the tunnel. Two types of spot heat detectors were installed along the center of the tunnel ceiling. The sampling pipe for the smoke detection system was also installed along the center of the tunnel ceiling. A schematic showing the setup of the detectors/detection systems in the tunnel is shown in Figure 3.1. [8].

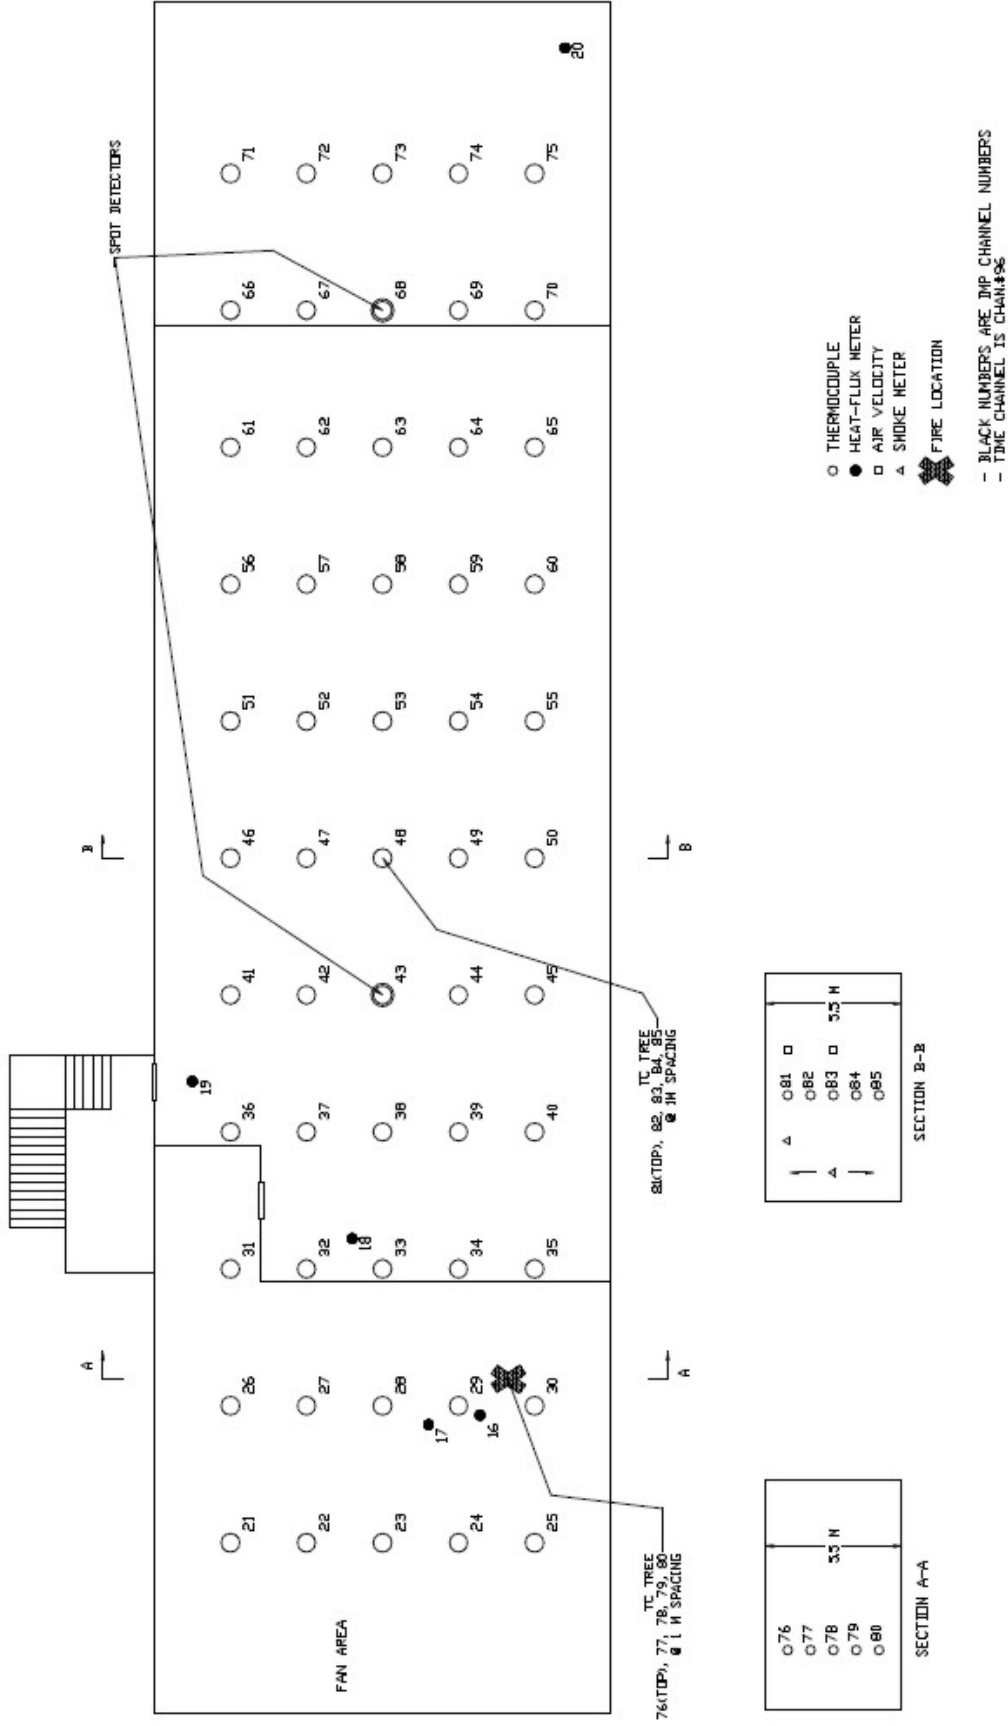
Figure 4.2. Schematic of instrumentation in the test tunnel

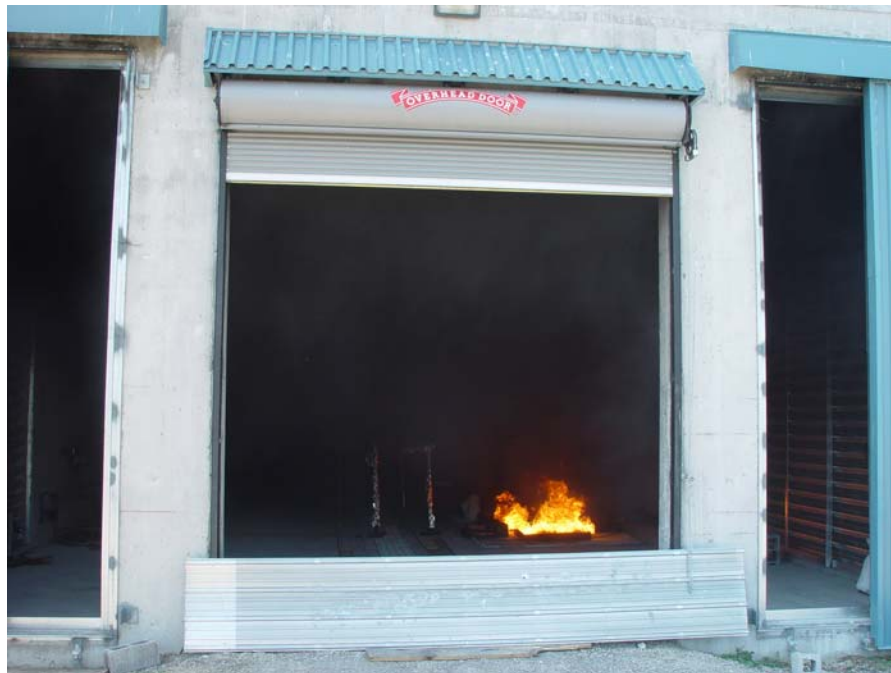
Figure 6.1. The setup of the door and the two side louvers at air velocity of 1.5 m/s

In order to achieve the targeted air velocity of approximately 3 m/s at the fire source, the side louver at the south side of the door was closed. The setup of the door and the side louver at the north side of the door were the same as the 1.5 m/s air speed.

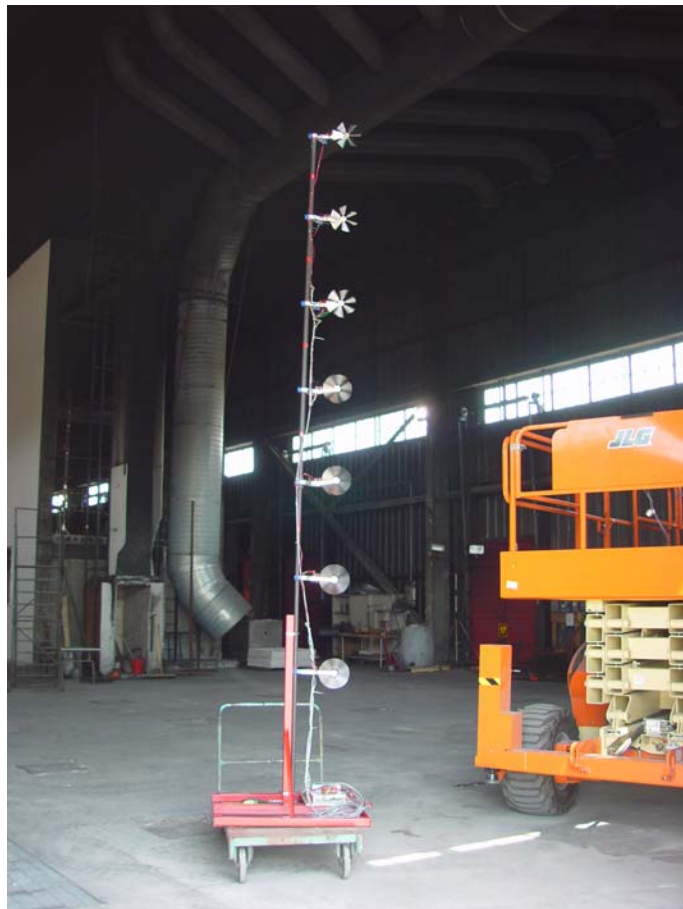
**Figure 6.2. Photograph of the air velocity meter tree**

The measurements of the air velocity in the tunnel were conducted by placing the air velocity measuring tree at the thirty-nine predetermined points in the tunnel shown in Figure 6.3.

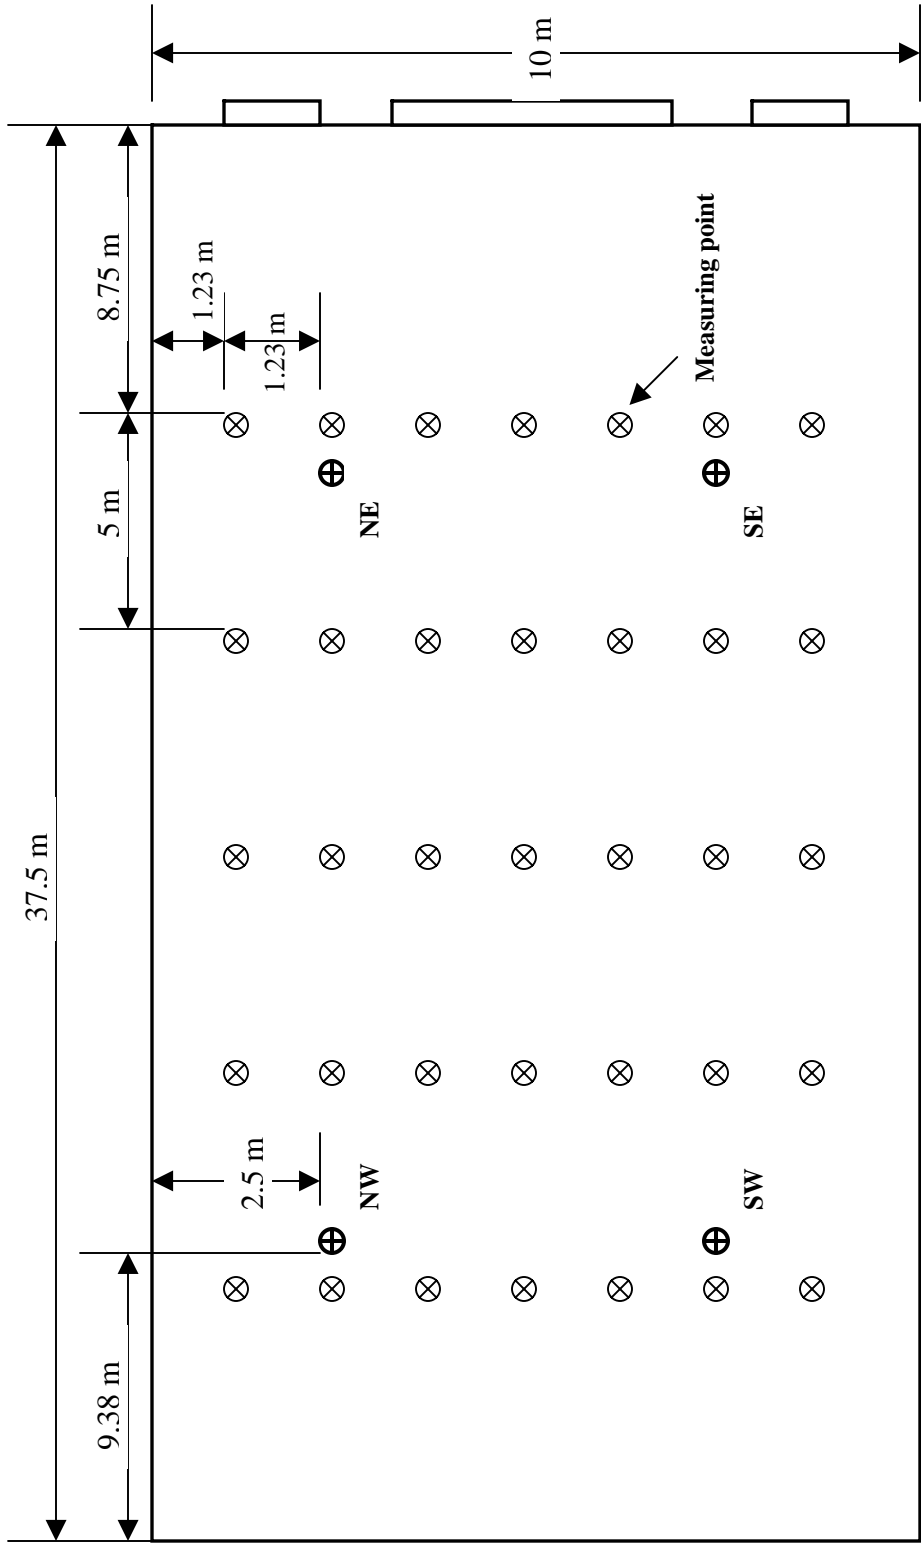
Figure 6.3. View of measuring points of air velocity in the tunnel

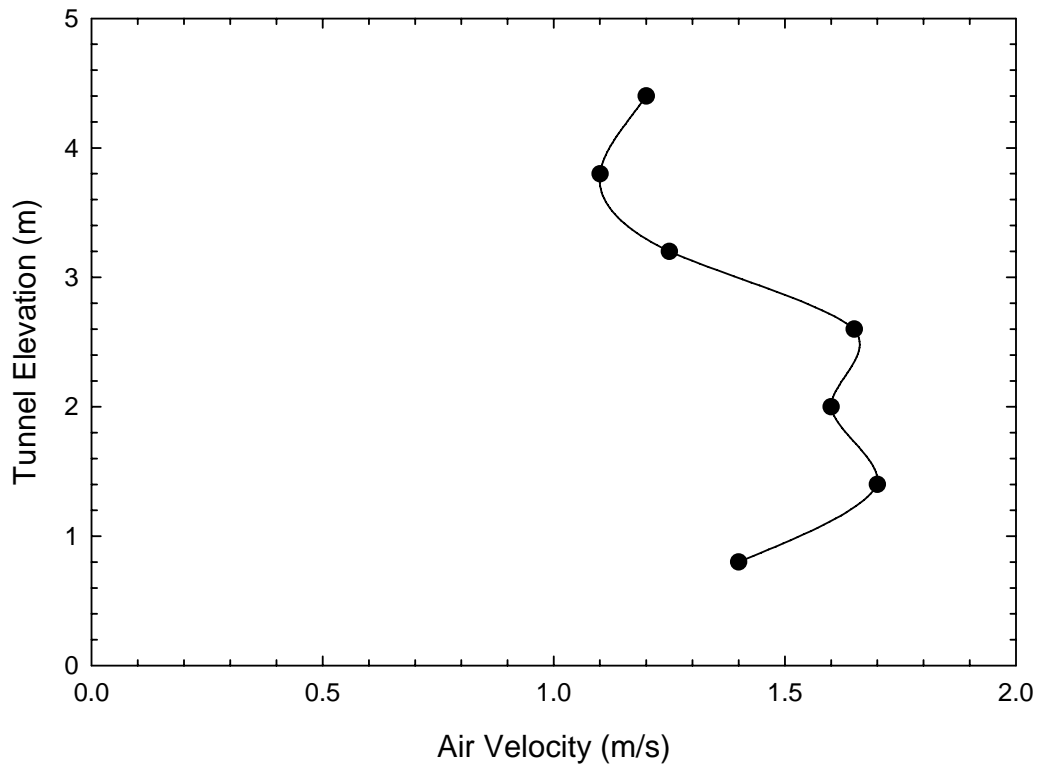
**Figure 6.4. Variation of air velocity with elevation near the fire location, when targeted velocity in the tunnel was 1.5 m/s.**

Figure 6.4 shows the variation in air velocity with elevation near the fire location, when the air velocity in the tunnel was targeted at 1.5 m/s. Test results demonstrated that the air velocity was approximately 1.4 m/s near the ground and was 1.6 m/s at the mid-height of the tunnel. The air velocity in the upper portion of the tunnel was lower than in the lower portion of the tunnel. The average air velocity near the fire location was approximately 1.5 m/s.

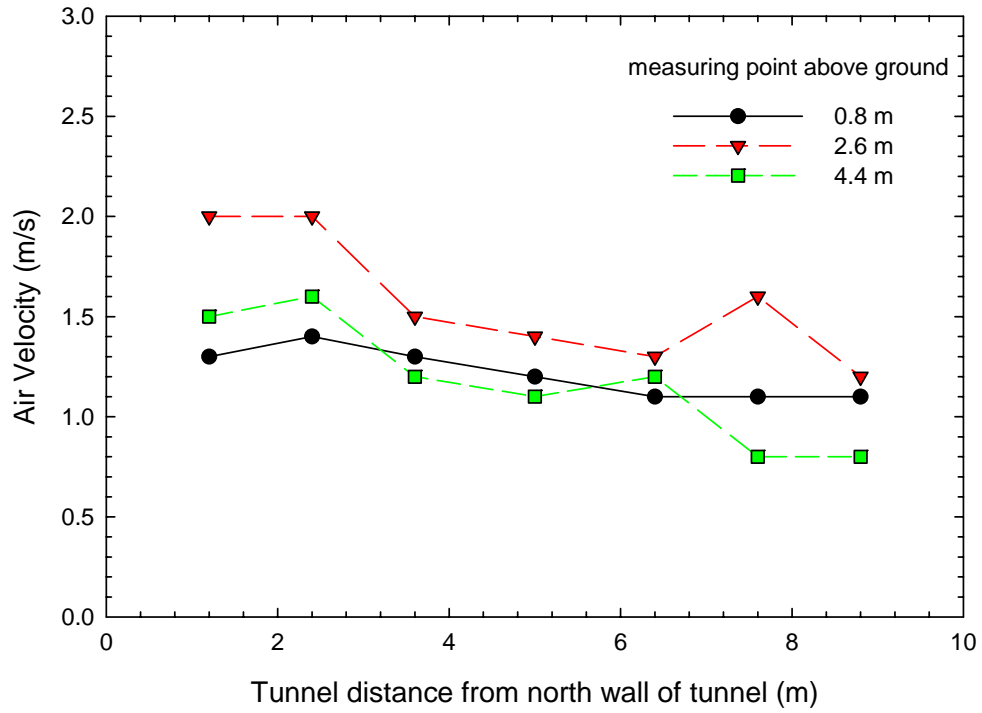
Figure 6.5. Air velocities across the tunnel near the fire location

Figures 6.5 and 6.6 show the distribution of air velocity across the tunnel near the fire location and along the centreline of the tunnel, when the air velocity in the tunnel was targeted at 1.5 m/s. Test results suggested that the airflow was distributed relatively uniformly in the tunnel. The air velocity in the North section of the tunnel where the fire source was placed was slightly higher than in the South section of the tunnel. The air velocity did not change significantly along the centerline of the tunnel. The variation of air velocity across the tunnel at different locations in the tunnel was similar to that near the fire location.

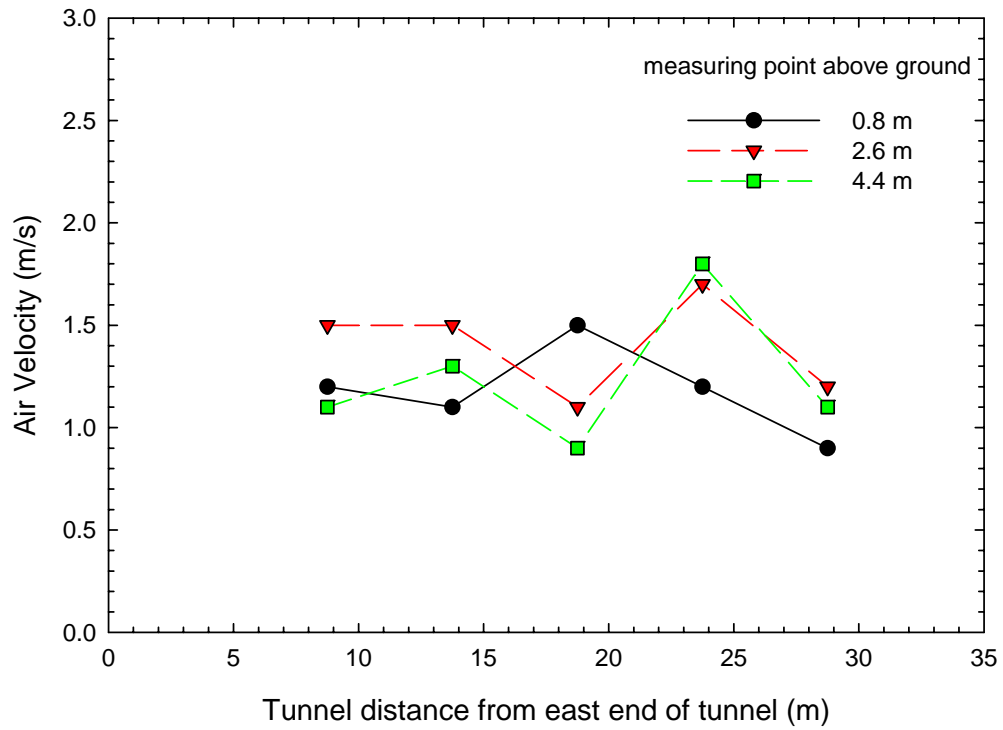
Figure 6.6. Air velocities along the centerline of the tunnel

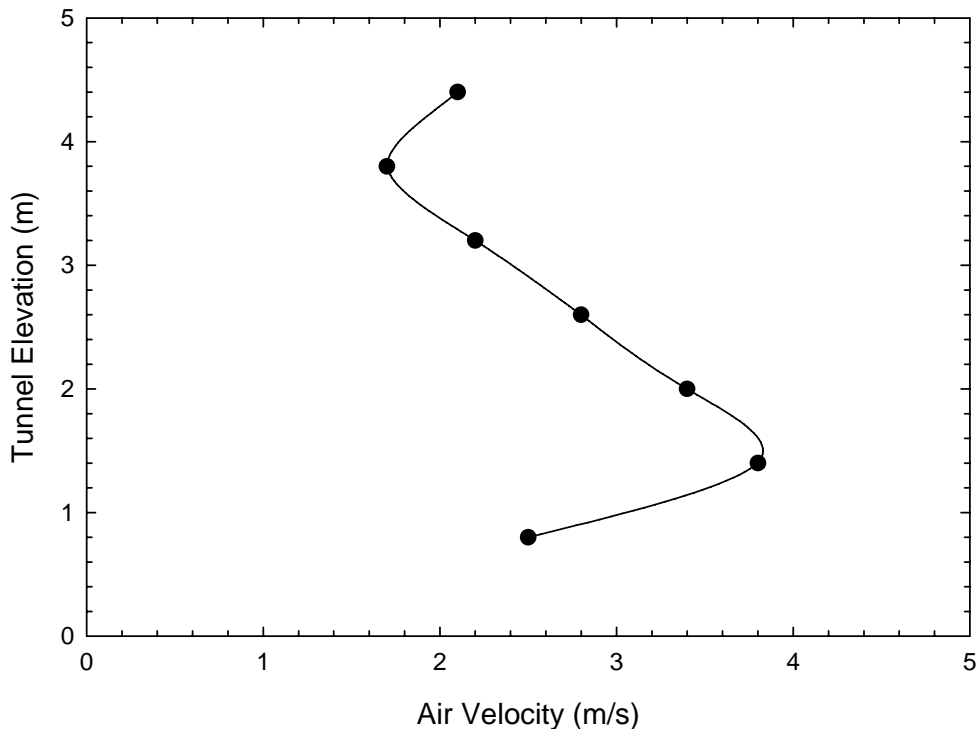
Figure 6.7. Variation of air velocity with elevation near the fire location, when the targeted velocity in the tunnel was 3 m/s.

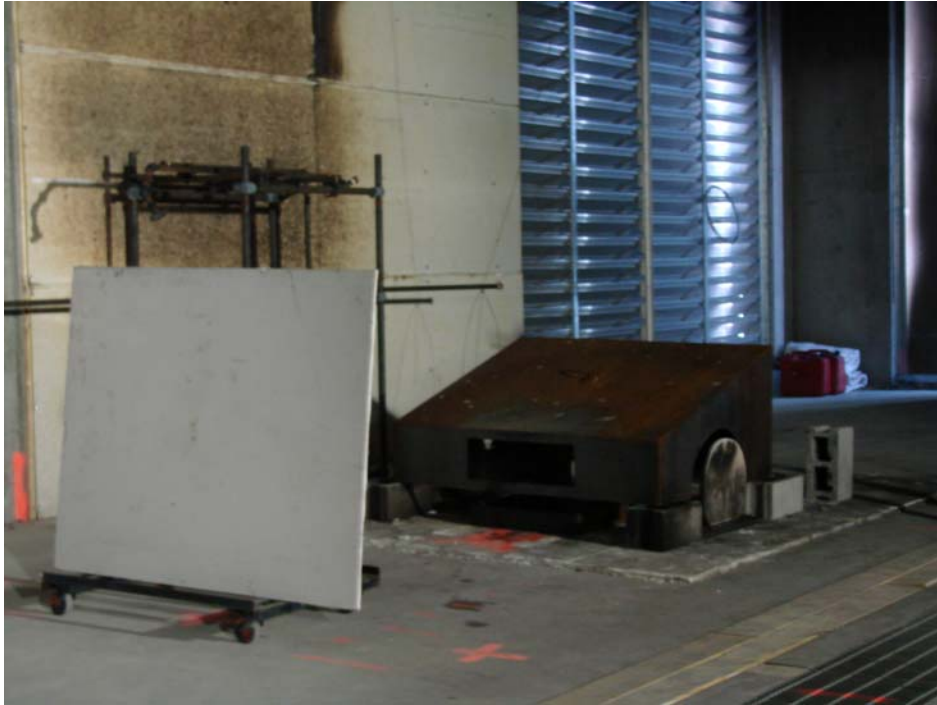
**Figure 7.1. Schematic of the setup for a fire underneath a vehicle**

The pool fires located underneath a simulated vehicle were designed to simulate a fire incident in which two vehicles crashed and fuel leaked from one of the vehicles and formed a pool fire underneath the vehicle. The setup of the fire scenario for a pool fire located underneath a vehicle is shown in Figure 7.1. A fuel pan was placed underneath a simulated vehicle. The mockup had the same footprint (1.5 m wide by 2.4 m long) as the bottom area of a standard passenger vehicle. The gap between the bottom of the simulated vehicle and the ground was 0.3 m. A plate with a size of 1.5 m wide by 1.2 m high, simulating a crashed car located between the fire source and the wall-mounted detectors, was placed 1.5 m in front of the fire source and 0.3 m above the ground. The setup of the fire scenario was the same as used in Task 2 of the project [8]. Results from Task 2 showed that it was a challenge for fire detectors/detection systems to detect the fire located underneath the vehicle, and the vehicle body located above the pool fire had a substantial impact on the combustion during the fire.

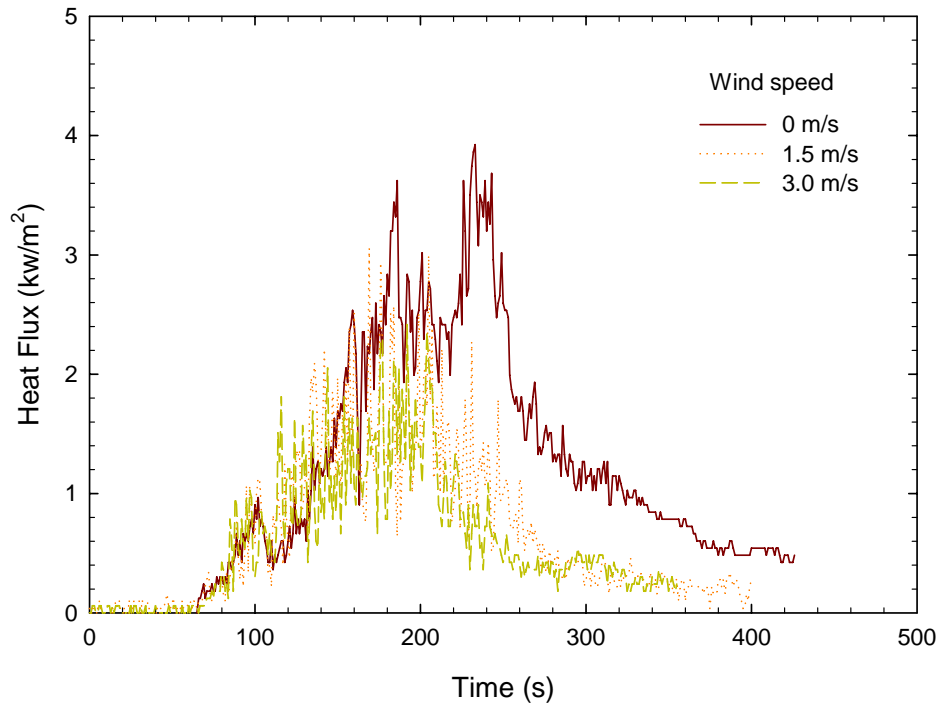
**Figure 7.2.** Heat flux measured at 1 m from a 0.36 m<sup>2</sup> fire located underneath a vehicle at different airflow velocities

Figures 7.2 through 7.4 show the impact of airflow velocity on the heat flux produced by three fires of different sizes located underneath the vehicle. The heat flux was measured 1 m from the fire source. The heat fluxes produced by two large fires located underneath the vehicle were also compared with those produced under non-ventilation conditions in tests conducted in Task 2.

Test results showed that the heat fluxes produced by a 0.36 m<sup>2</sup> fire measured 1 m from the fire source decreased with an increase in airflow speed in the tunnel. This may be attributed to the fact that the airflow tilted the flames away from the heat flux meter. The heat fluxes produced by the two larger fires with a 1.5 m/s longitudinal airflow, particularly by the 2 m<sup>2</sup> fires, were higher than those produced under non-ventilated conditions. The heat fluxes decreased with the airflow speed at 3 m/s. For large fires, an airflow velocity higher than 1.5 m/s was required to tilt the flames. The fuel burning times, as shown in Figures 7.3 and 7.4, were shorter than those under non-ventilated conditions. This suggests that the longitudinal airflow enhanced the burning rate for the large fires located underneath the vehicle, resulting in an increase in fire growth rate and fire size.

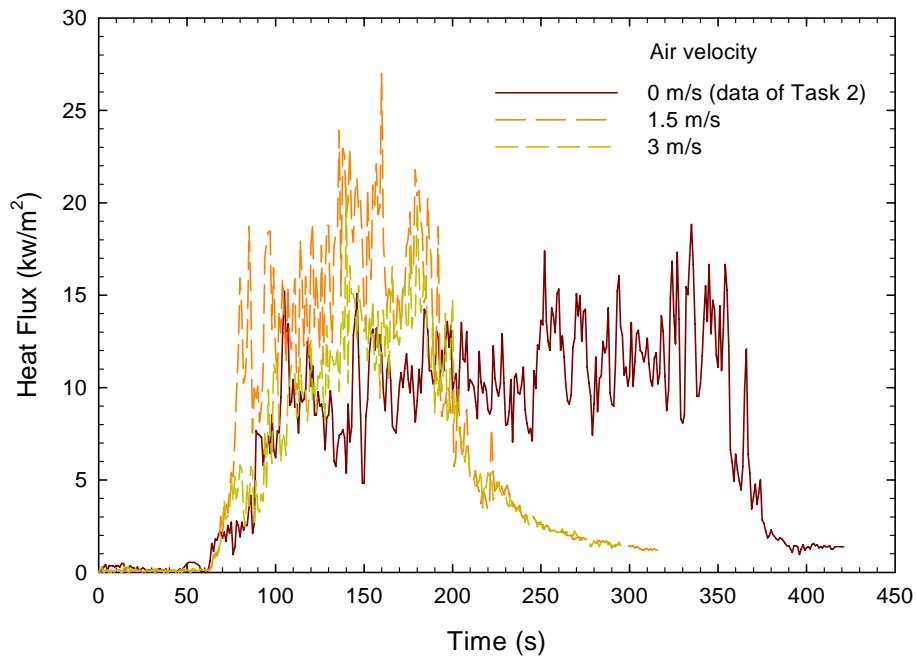
**Figure 7.3.** Heat flux measured at 1 m from a 1.0 m<sup>2</sup> fire located underneath a vehicle at different airflow velocities

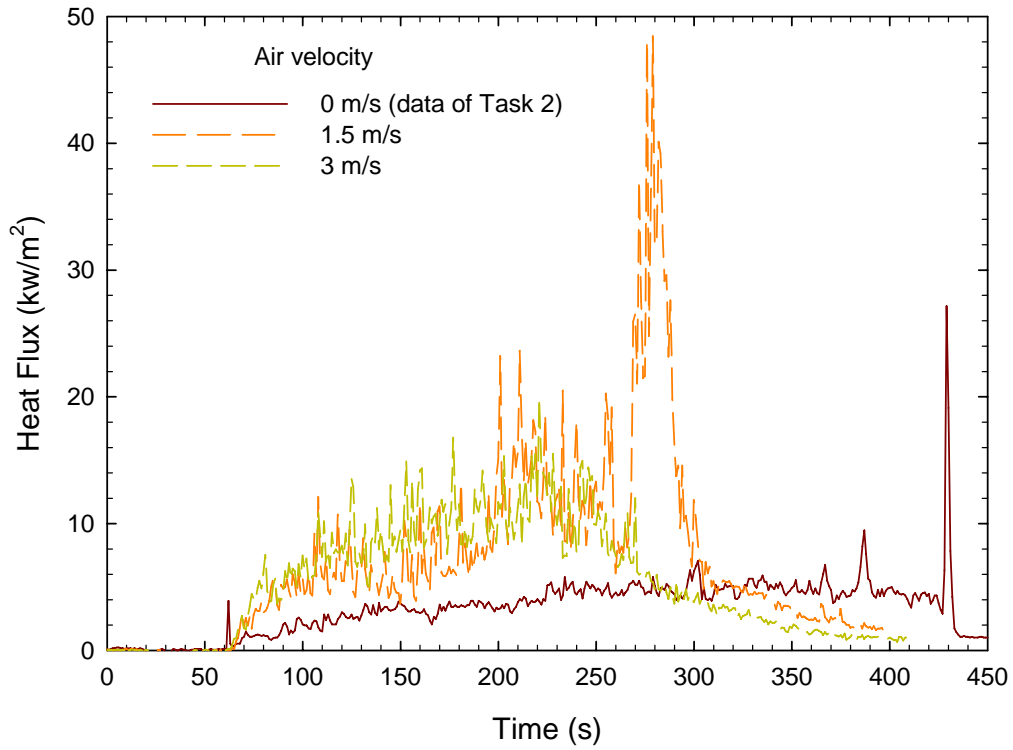
**Figure 7.4. Heat flux measured at 1 m from a 2.0 m<sup>2</sup> fire located underneath a vehicle at different airflow velocities**

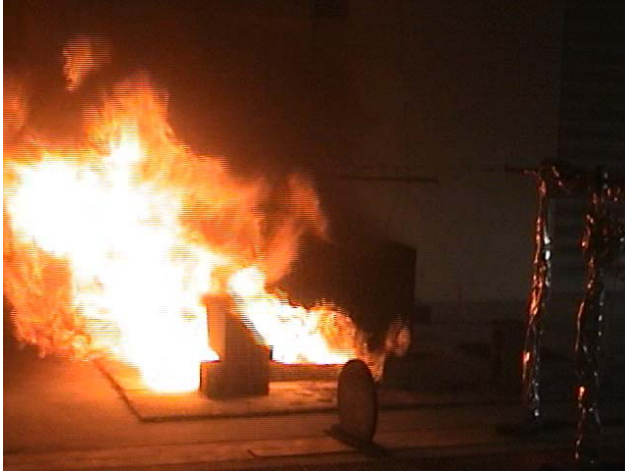
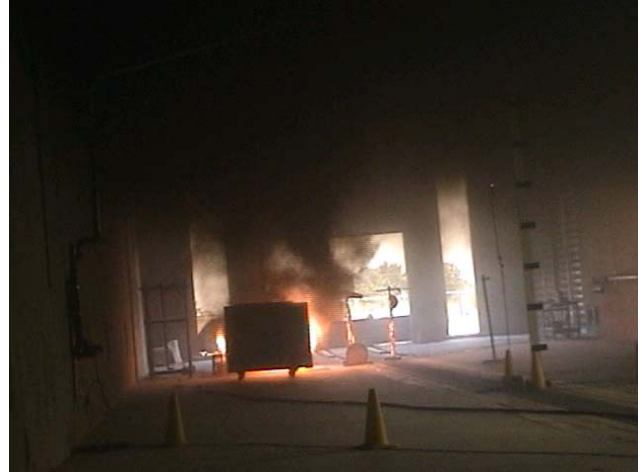
Figure 7.8. A 1.0 m<sup>2</sup> gasoline pool fire located underneath the vehicle with 1.5 m/s airflow velocity

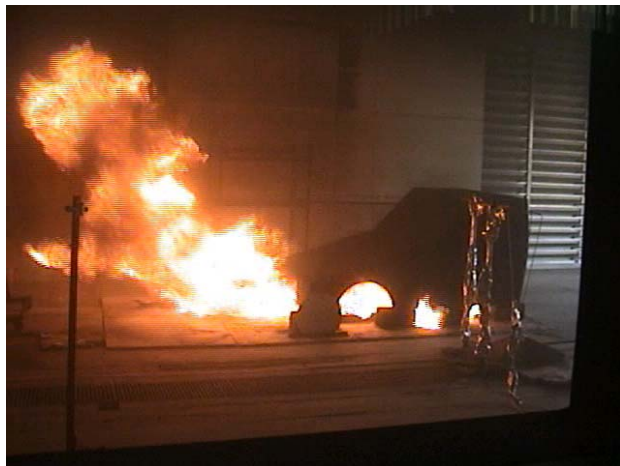
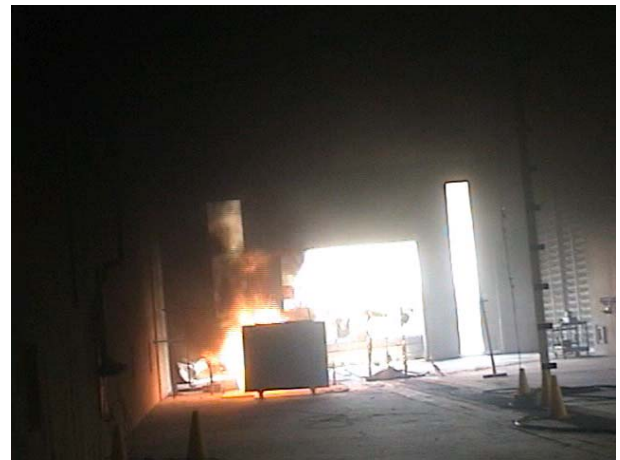
Figure 7.10. A 2.0 m<sup>2</sup> gasoline pool fire located underneath the vehicle with 1.5 m/s airflow velocity

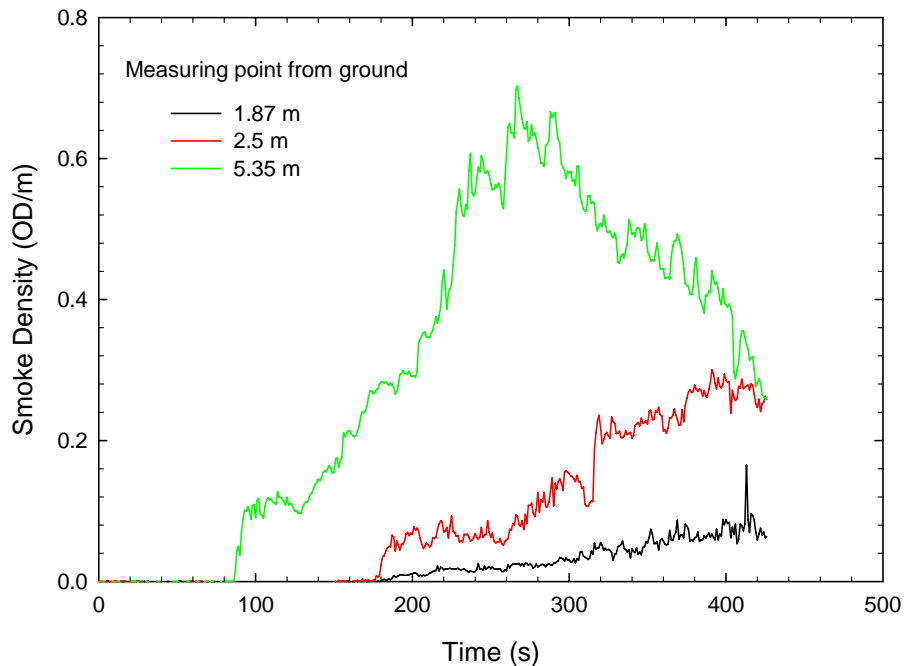
Figure 7.12. Smoke density measured at the middle of the tunnel for a  $0.36 \text{ m}^2$  fire located underneath a vehicle with minimal airflow.

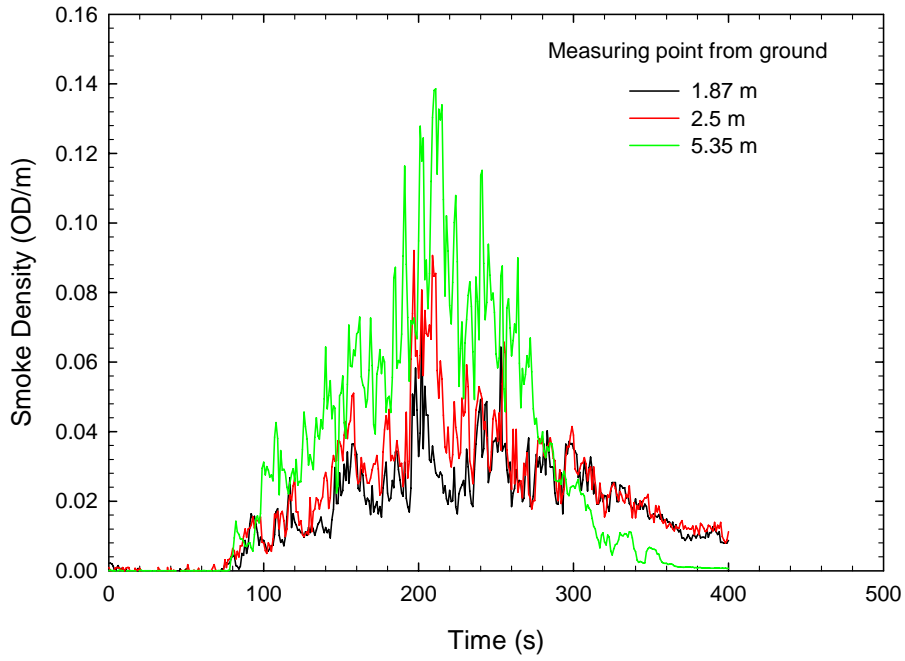
**Figure 7.13. Smoke optical density measured at the middle of the tunnel for a 0.36 m<sup>2</sup> fire located underneath a vehicle with an airflow speed of 1.5 m/s**

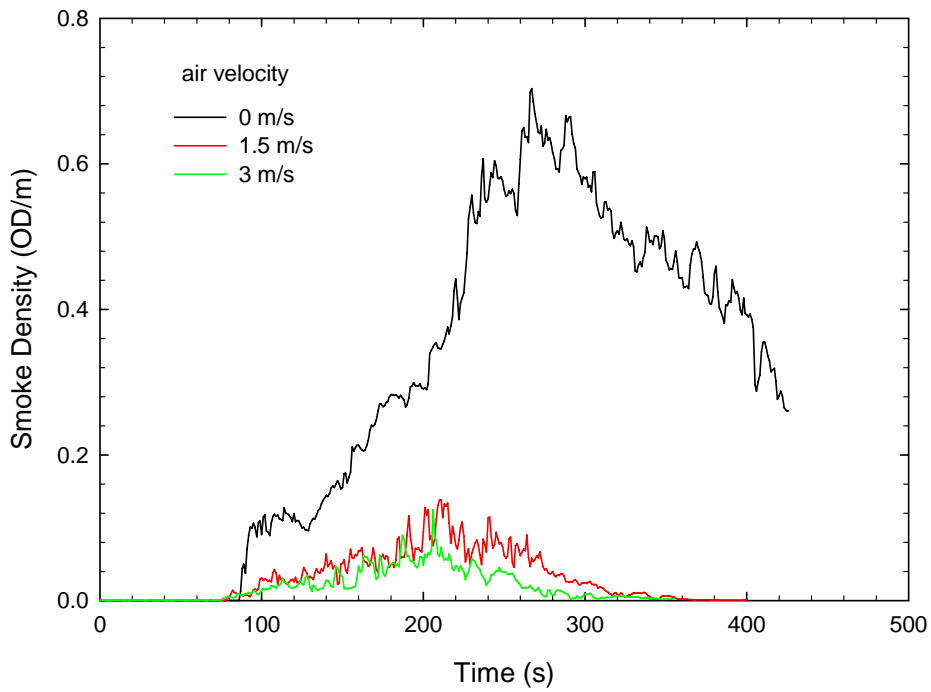
**Figure 7.14. Smoke density measured 150 mm below the tunnel ceiling for a 0.36 m<sup>2</sup> fire located underneath a vehicle at three airflow speeds.**

Figure 7.14 compares the variation in smoke optical density 150 mm below the ceiling produced by the  $0.36 \text{ m}^2$  fire at three airflow speeds. The smoke optical density near the ceiling of the tunnel decreased with an increase in airflow speed.

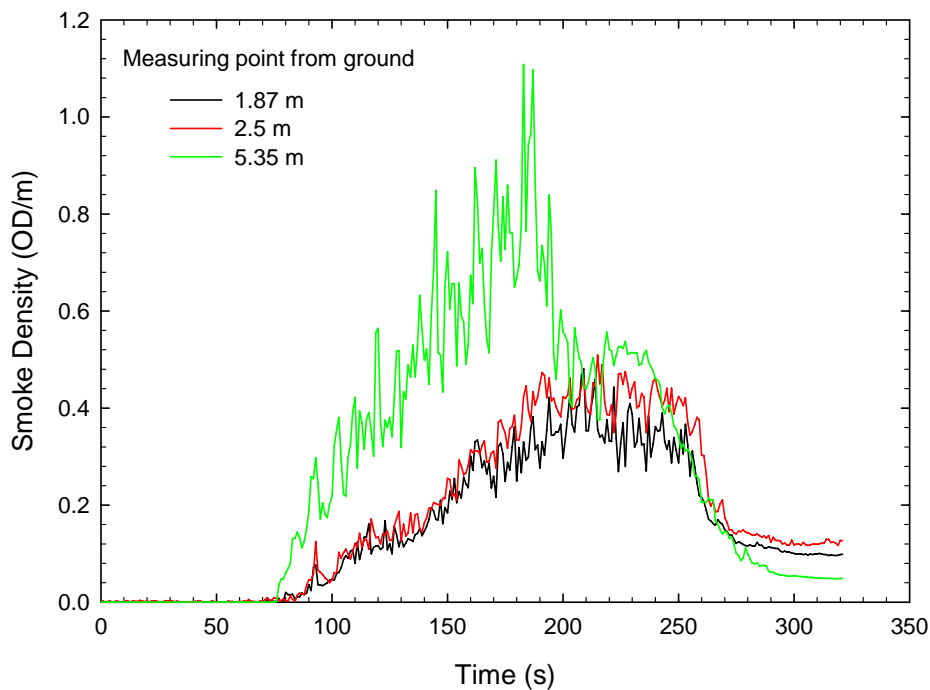
**Figure 7.15. Smoke density measured at the middle of the tunnel for a 1.0 m<sup>2</sup> fire located underneath a vehicle with an airflow speed of 1.5 m/s**

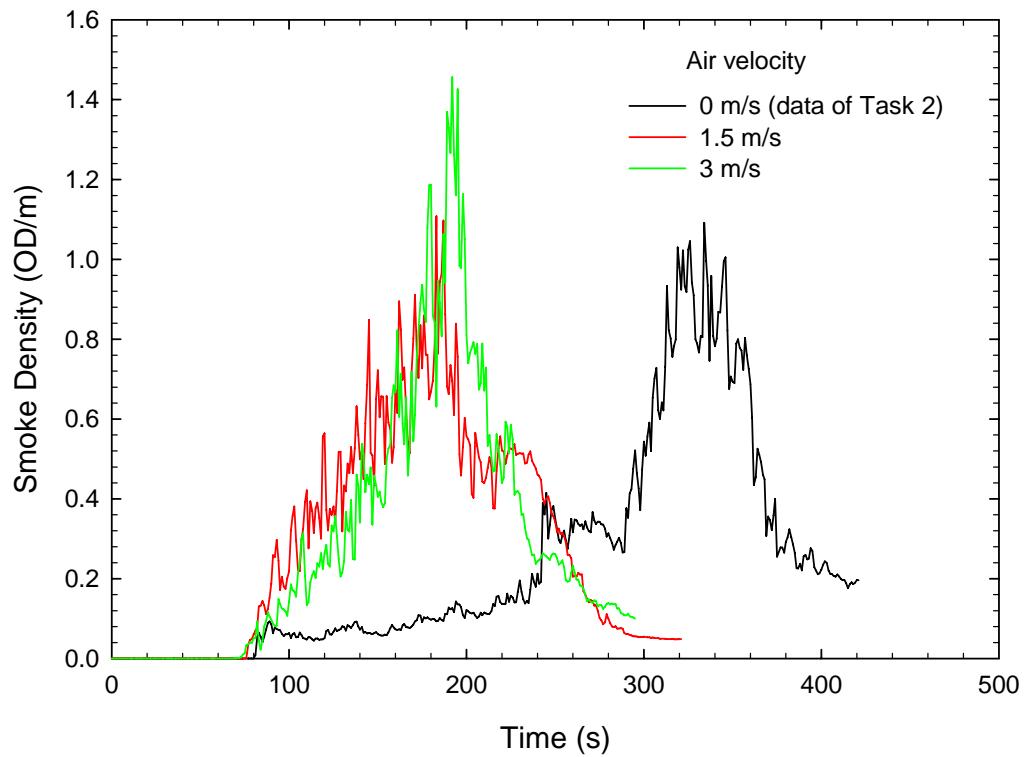
Figure 7.16. Smoke density measured 150 mm below the tunnel ceiling for a 1.0 m<sup>2</sup> fire located underneath a vehicle at three airflow speeds.

Figure 7.16 compares the smoke optical density measured 150 mm below the ceiling produced by a 1.0 m<sup>2</sup> fire at three airflow speeds. It shows not only that the fuel burning time under airflow conditions was much shorter than that under non-ventilated conditions, but also the smoke optical density near the ceiling under airflow conditions was higher than that under non-ventilated conditions, as the burning rate of the fire located underneath the vehicle was increased.

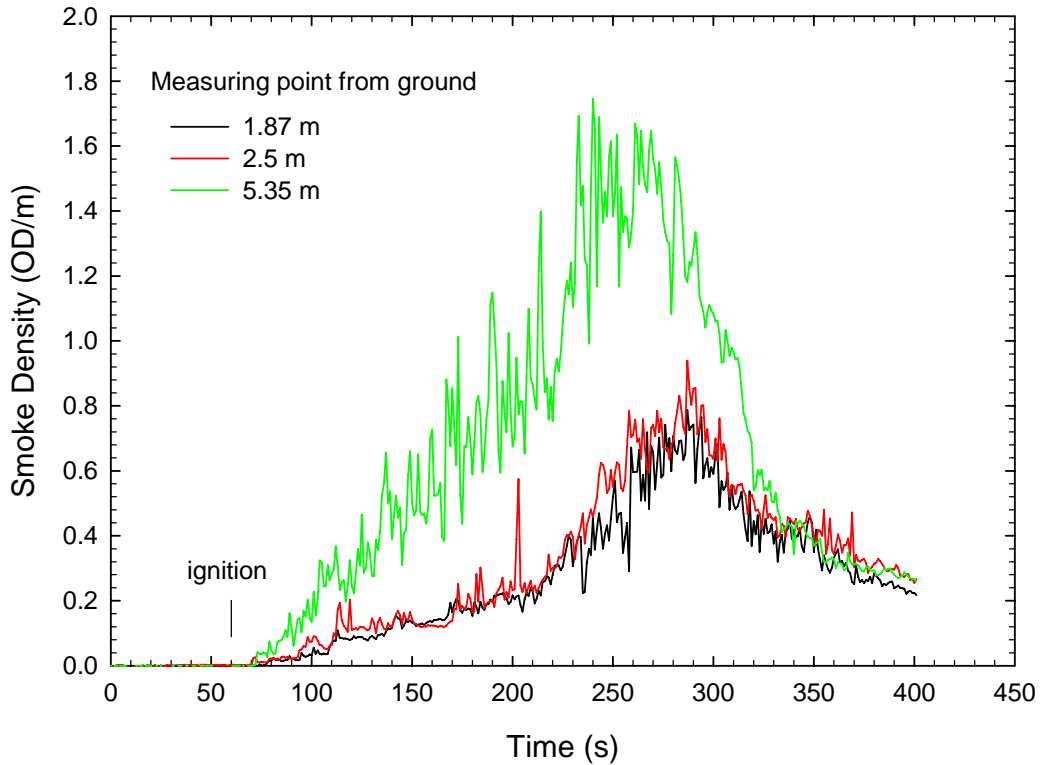
**Figure 7.17. Smoke optical density measured at the middle of the tunnel for a 2.0 m<sup>2</sup> fire located underneath a vehicle at an airflow speed of 1.5 m/s**

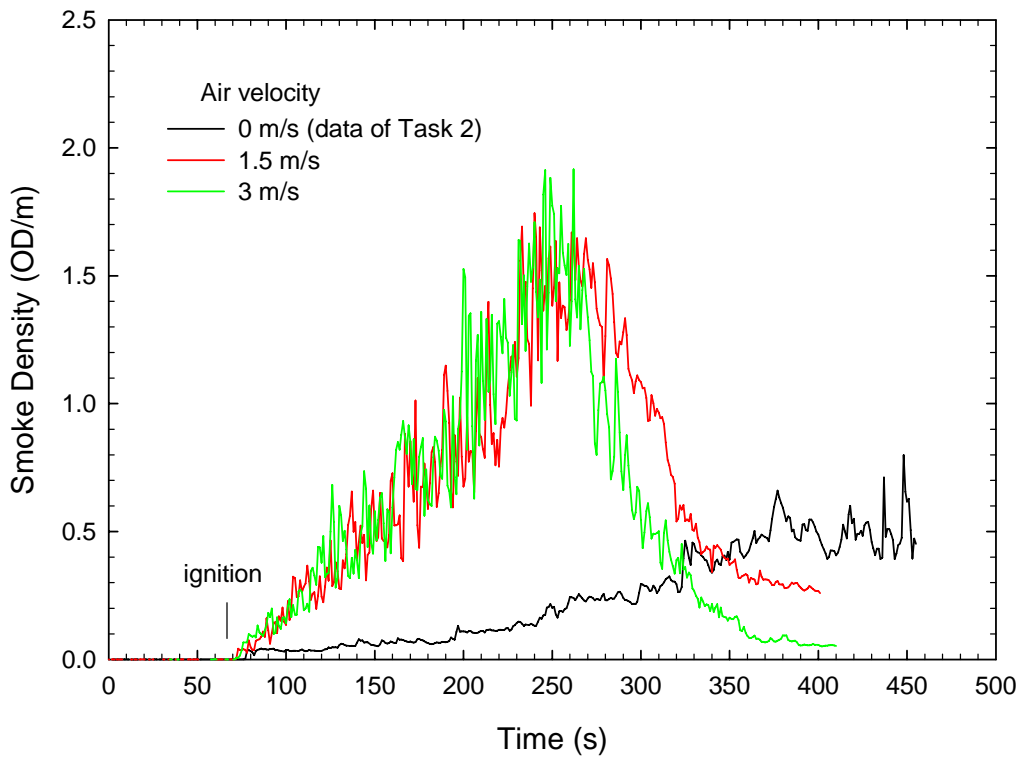
**Figure 7.18. Smoke optical density measured 150 mm below the tunnel ceiling for a 2.0 m<sup>2</sup> fire located underneath a vehicle with three airflow speeds.**

Figure 7.18 also shows that the smoke optical density produced by a 2.0 m<sup>2</sup> fire under airflow conditions was much higher than that under non-ventilated conditions. The increase in the smoke optical density, however, was limited when the air velocity was increased to 3 m/s. These results were consistent with the changes in heat fluxes produced by the fires.

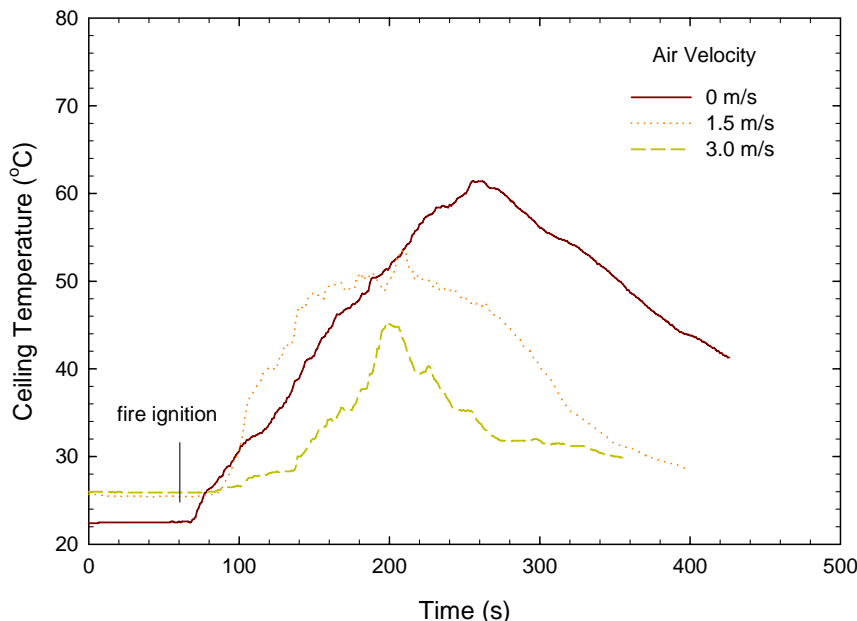
**Figure 7.19. Ceiling temperatures measured at Thermocouple #33 at center of the tunnel ceiling with a  $0.36 \text{ m}^2$  gasoline pan fire at three airflow velocities**

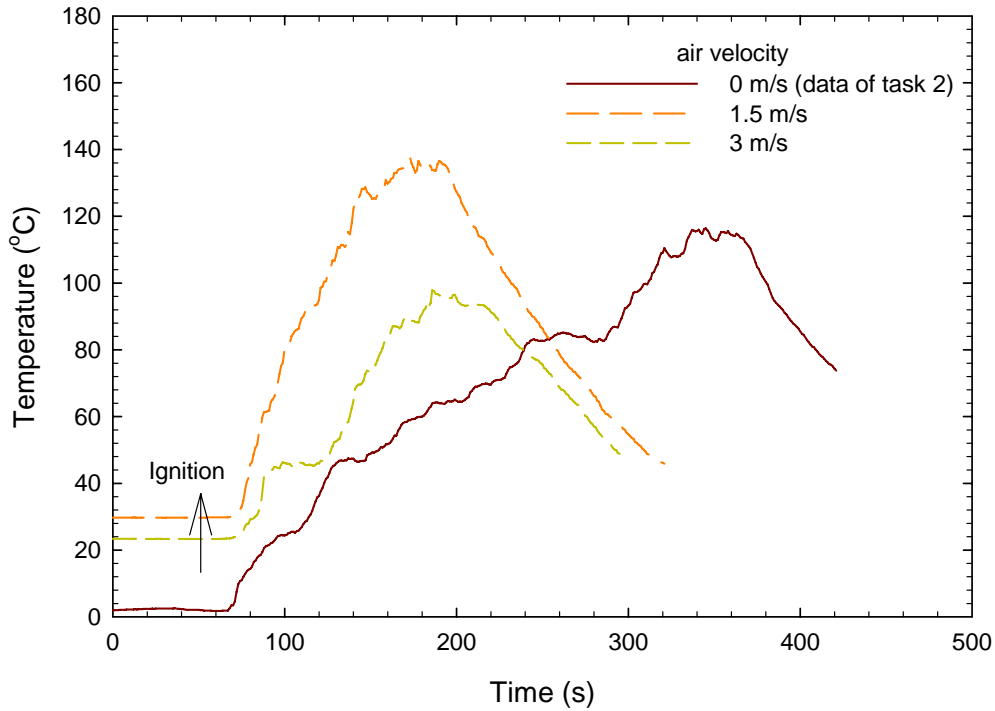
**Figure 7.20. Ceiling temperatures measured at Thermocouple #33 at center of the tunnel with a 1.0 m<sup>2</sup> gasoline pan fire at three airflow velocities**
